*Bell 206B-III Accident*

Accident Report No. 11/02

Occurred on 24 May, 2002 to Bell 206B III Helicopter Registration

No. 4x-BJH in the "Nesher" Plant Near Ramla, Israel

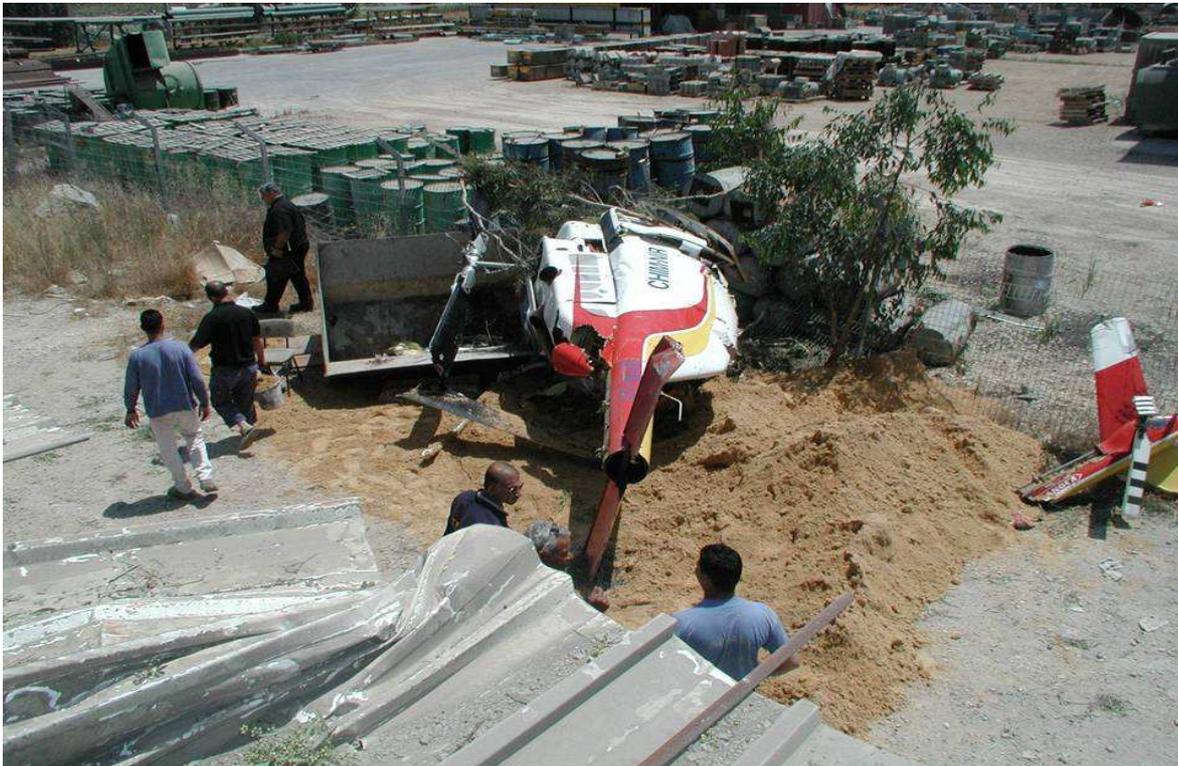
While performing the first path of a low-level aerial photography mission, conducted over the "Nesher" cement factory, the helicopter's engine flamed-out when it passed through the air exhaust from one of the plant's chimneys. The pilot performed an autorotation descent, and as could not locate an open field suitable for landing, he elected to land on a tall tree.

The helicopter struck the upper section of the tree, then fell down and hit the ground with its forward part of the belly, and crashed on a tall fence. The helicopter was destroyed and its three occupants were seriously injured and evacuated to nearby hospitals.
