ATSB TRANSPORT SAFETY REPORT

Aviation Research and Analysis - AR-2009-041

Avoidable Accidents No. 1

Low-level flying

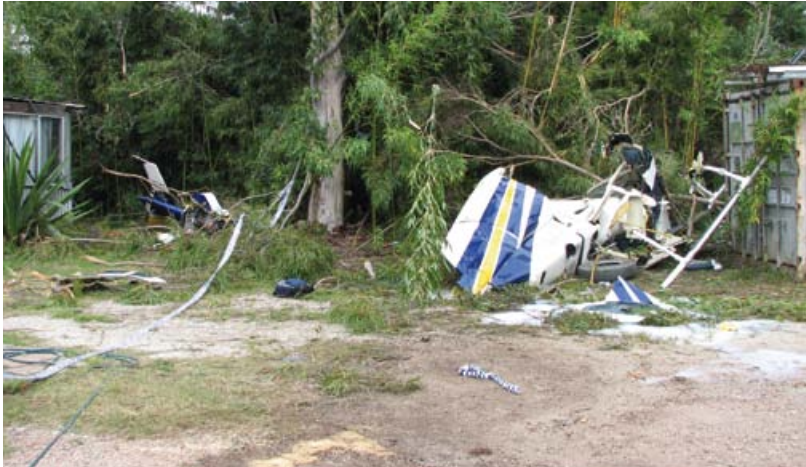
Main wreckage

The helicopter had been maintained and inspected appropriately and no mechanical defects were found that would have affected the safe flight of the helicopter. However, it was found that the helicopter was 28 kg over its maximum take-off weight (MTOW) limit at the time of the accident. One of the passengers confirmed they were not weighed prior to departing Bankstown airport.

The pilot would have had more time to assess and react to the loss of control situation had he operated the helicopter at the manufacturer's weight limitations and at 500 ft or more above ground level in accordance to civil aviation regulations.

Civil Aviation Advisory Publication (CAAP) 235-1(1) recommends using actual weights of occupants and baggage for light aircraft and helicopters with less than seven seats to avoid overloading <www.casa.gov.au/wcmswr/_assets/main/download/caaps/ops/235_1.pdf>.

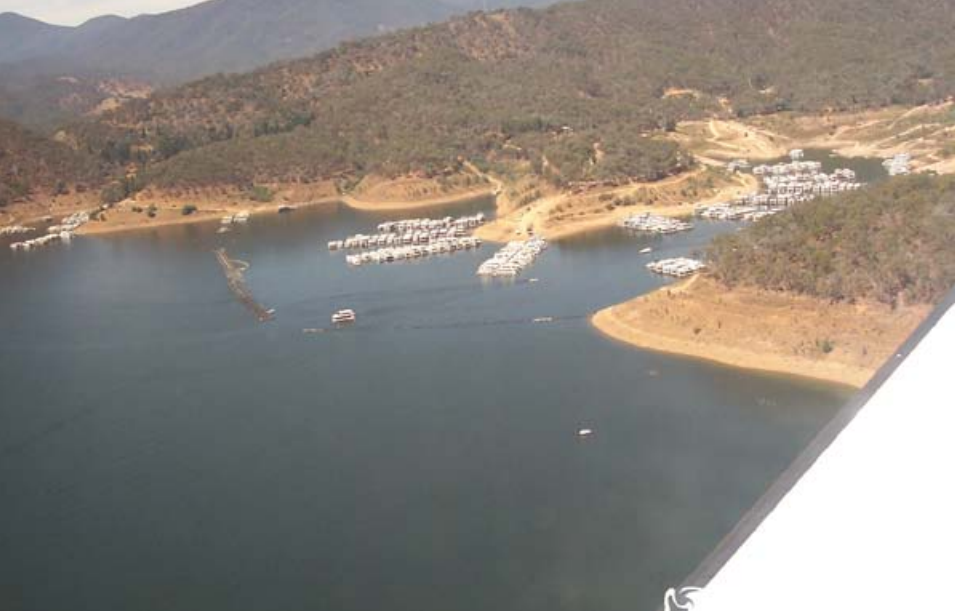
Lake Eildon, Victoria

The Piper PA-28 Cherokee Arrow aircraft struck high-voltage powerlines suspended over the lake. The aircraft was destroyed by the impact with the wire and with the water. All three passengers were fatally injured and the pilot's body could not be found.

The power line involved in the accident spanned a 2 km length across Lake Eildon. The aircraft struck the power cable at the lowest point of the span, which was only 133 ft above the water. Under relevant Australian Standards, the power line was not required to be fitted with marker devices as it was less than 295 ft (90 m) in height.

Do not rely on marker devices to alert you to the presence of powerlines. Powerlines under 295 ft (90 m) in height, as was the case in this accident, are not required under Australian Standards to be fitted with marker devices.

Familiarise yourself with the location of power lines by studying maps of the area before flight.

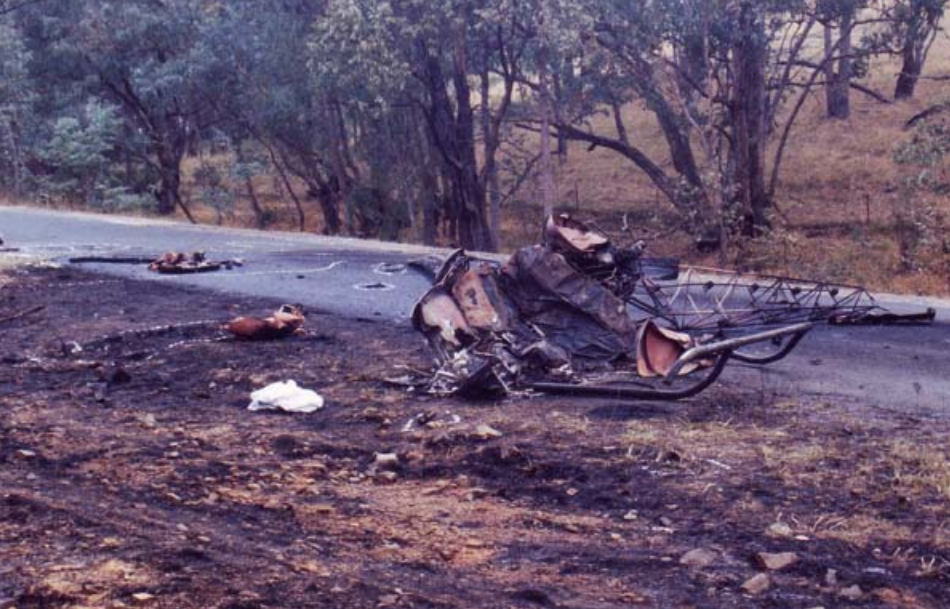
Accident site

The pilot borrowed an Agusta/Bell 47G helicopter to fly his sister to her wedding at the family property near Holbrook, New South Wales in February 1999. Witnesses reported that the helicopter was flying very low. As it traversed Chinaman's Gap, several kilometres from its destination, the helicopter struck powerlines and impacted the ground. The impact and subsequent fire destroyed the helicopter – brother and sister were killed.

Other pilots, who have regularly flown in the area, reported that the powerline involved (which was 102 ft (31 m) above the ground) was difficult to see because the poles were a long way apart and partially obscured by trees and that the cables blended with the background vegetation.
