Accident Report (abstract) by Tomy Ben Ari

Site of accident: 5 miles north west of Crete

Date of Accident: Approx 250 BC

Aircraft Type: Homebuilt, Man-Powered (ultralight class)

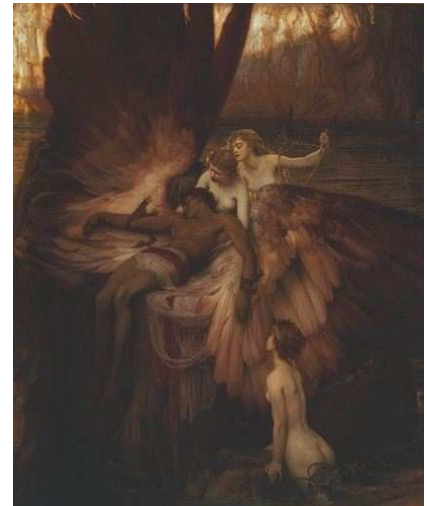
Actual photo of the accident investigation.
